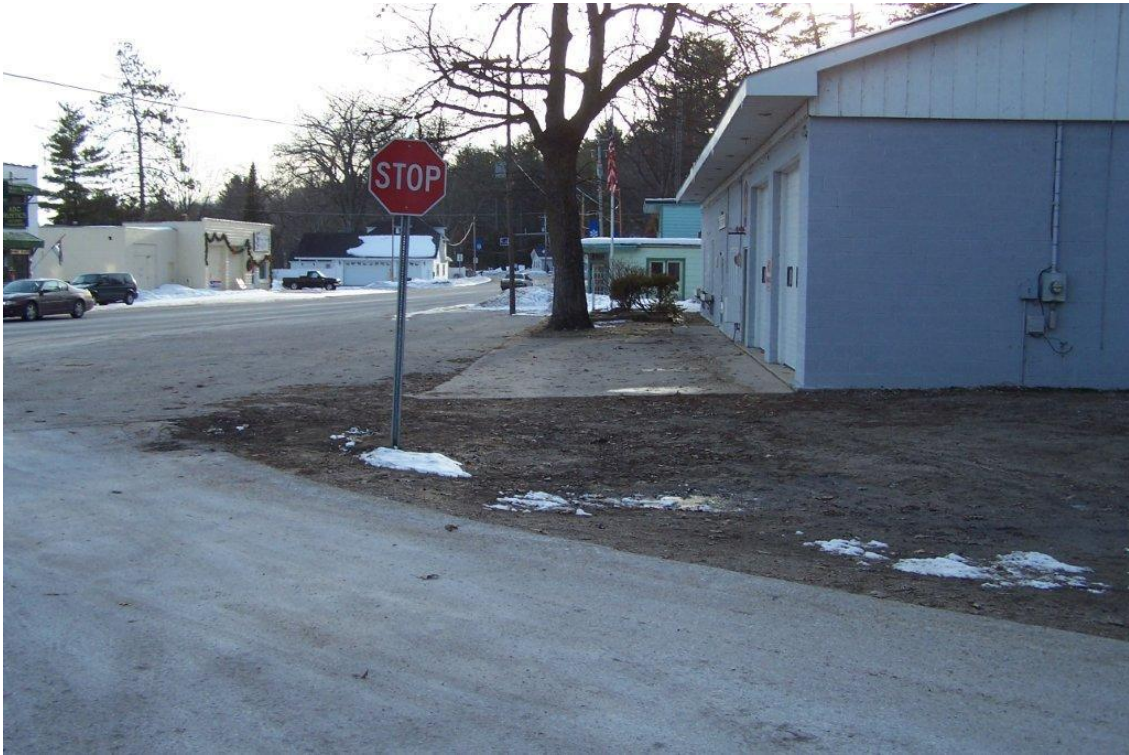
The roadway is poorly defined causing motorists to drive "everywhere". Note how the stop sign is far removed from the edge of M-27 highway. It is often ignored and drivers proceed to the edge of the M-27 or "coast" onto the highway. This intersection is dangerous and traffic patterns are often unpredictable.

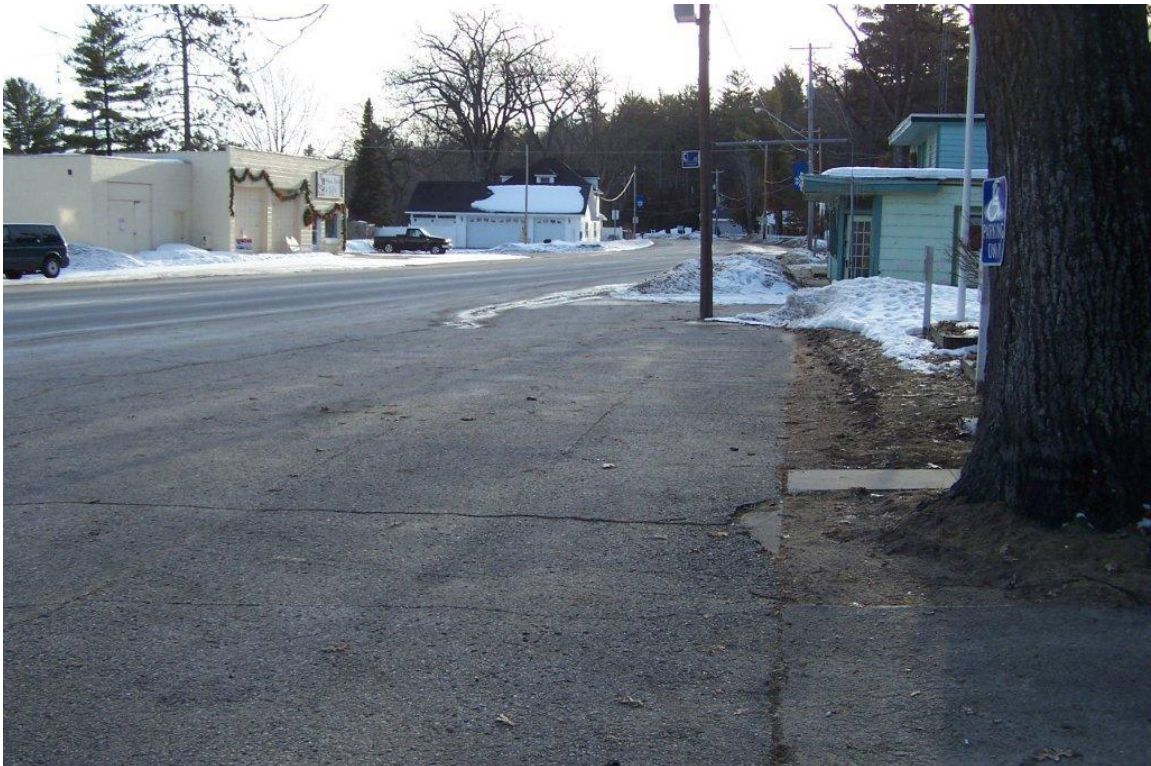
The "wide berth" of the driving area and lack of a defined right-of-way.

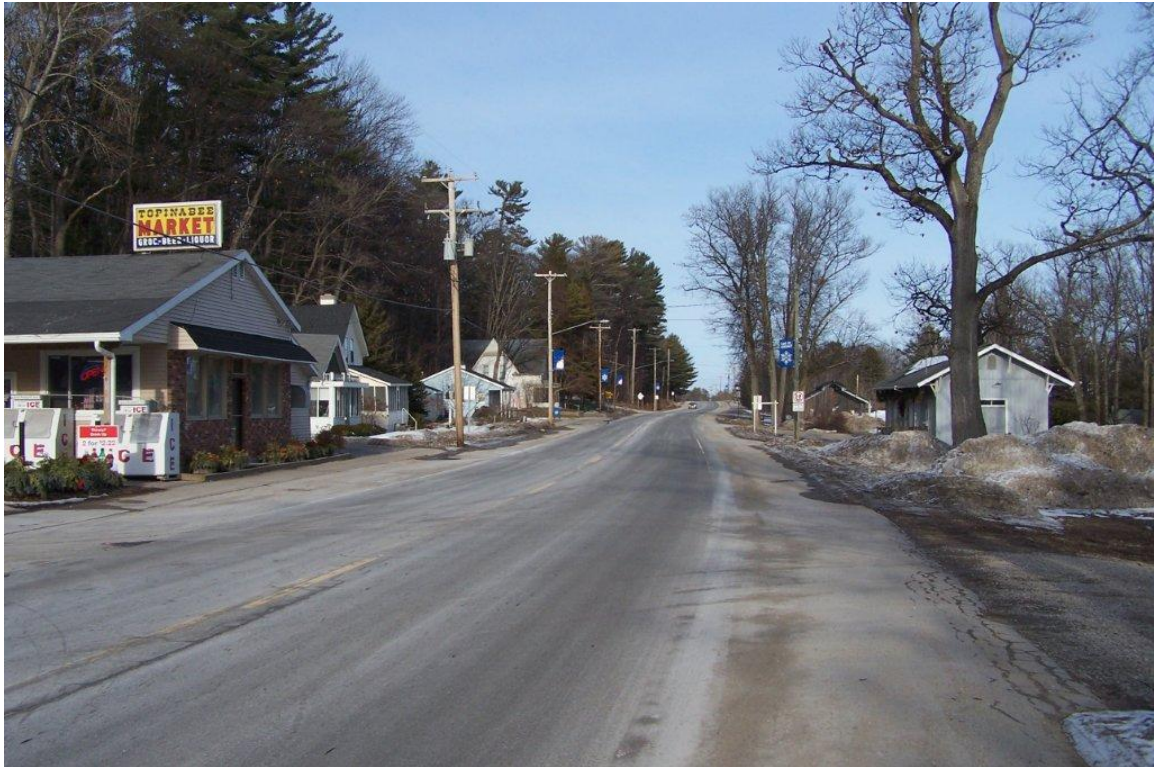
The M-27 highway is directly in front of the Topinabee Market. Cars and trucks park up to the front of the store where pedestrians must also walk. There is no definition between parking in front of businesses and M-27. Therefore, cars and trucks frequently park facing in the wrong direction against the flow of traffic. Pedestrian traffic from the beach and park areas (right) randomly cross over M-27 to access the Market.

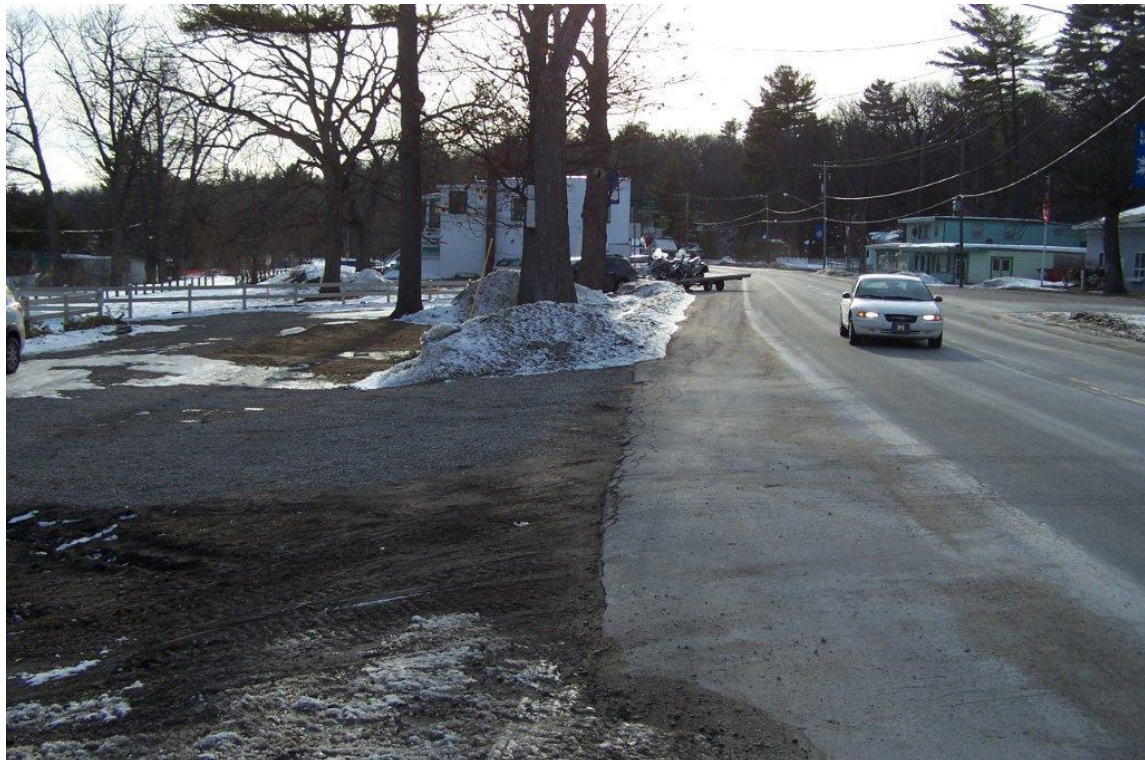
Snowmobile/trailer traffic moving from roadway into the park area. Note the limited definition of roadway, parking areas, pedestrian pathways.

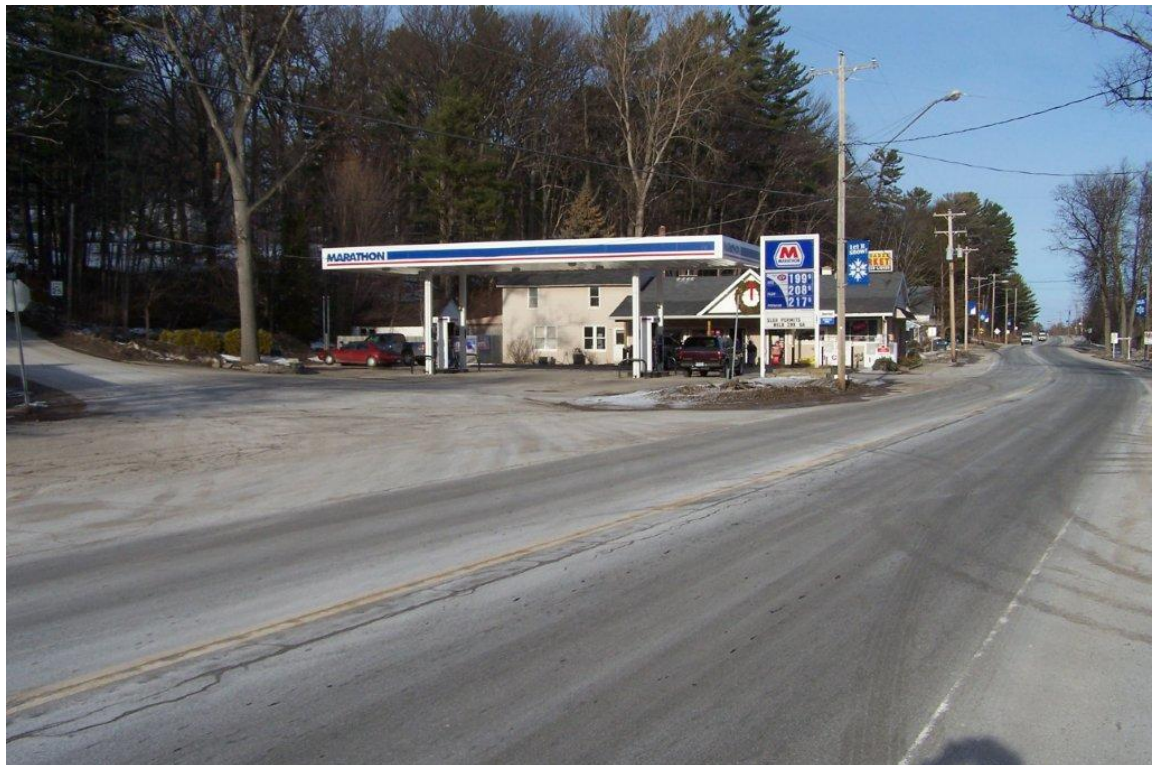
A lack of separation and definition between the M-27 roadway, walkway and side streets sets up a very dangerous situation for pedestrians who cross through this intersection on their way down the hill. The road coming down the hillside becomes a cascading torrent during rainstorms and all of the contaminated water drains directly into Mullett Lake.

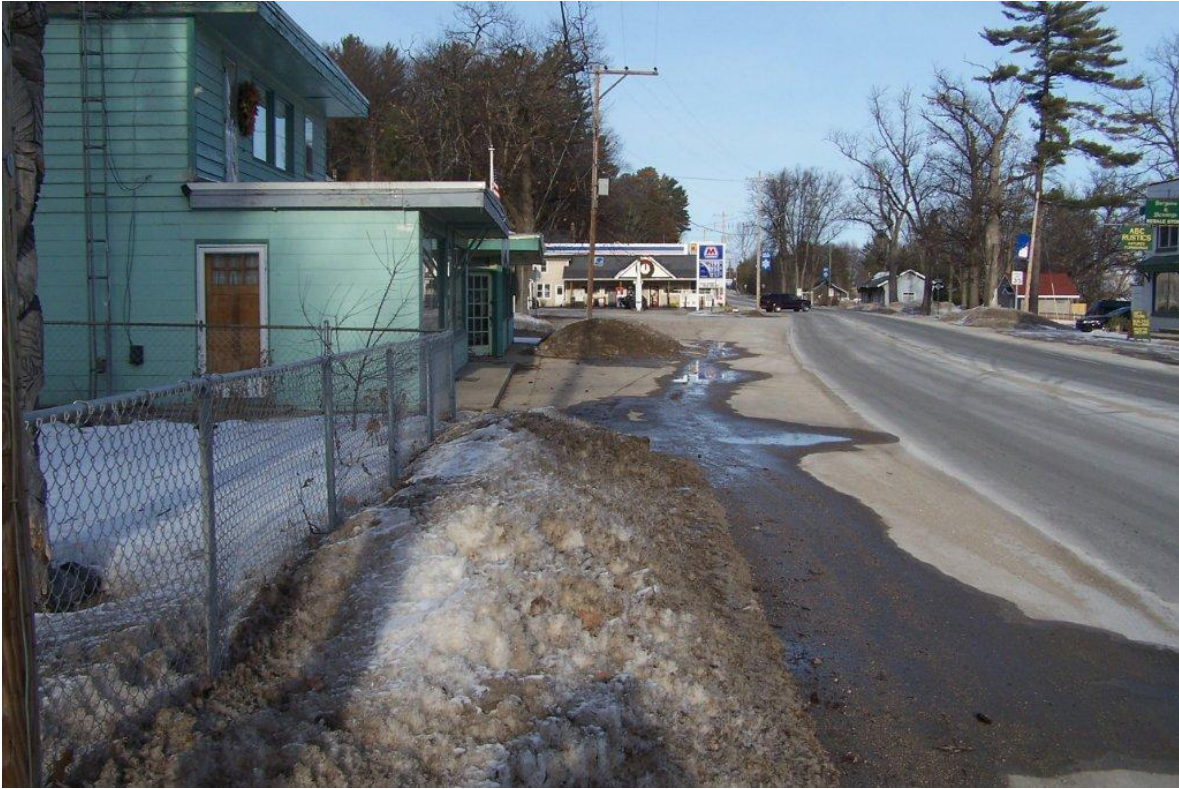
The roadbed comes directly up to the front of the business establishments (i.e. Hardware Store). There are no curbs or sidewalks to keep pedestrians safe.
